# **CORRECTIVE MEASURE IMPLEMENTATION REPORT**

Duwamish Sediment Other Area and Southwest Bank

Corrective Measure

Boeing Plant 2

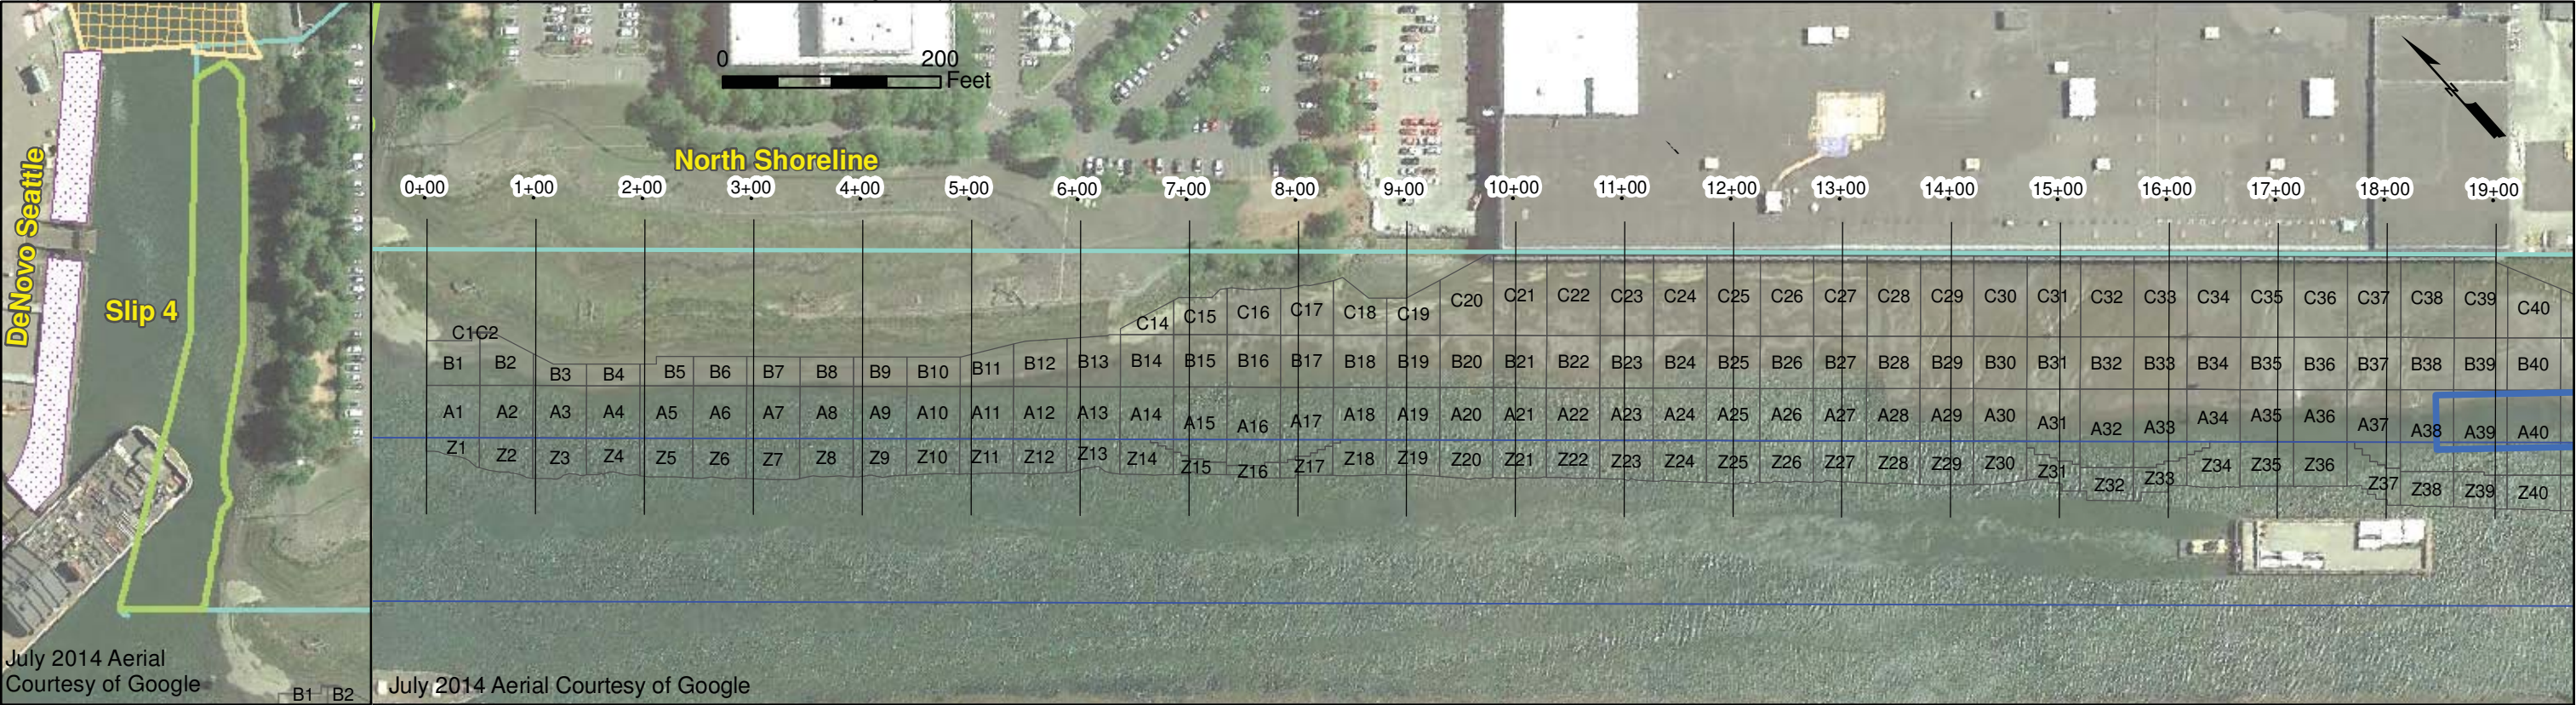
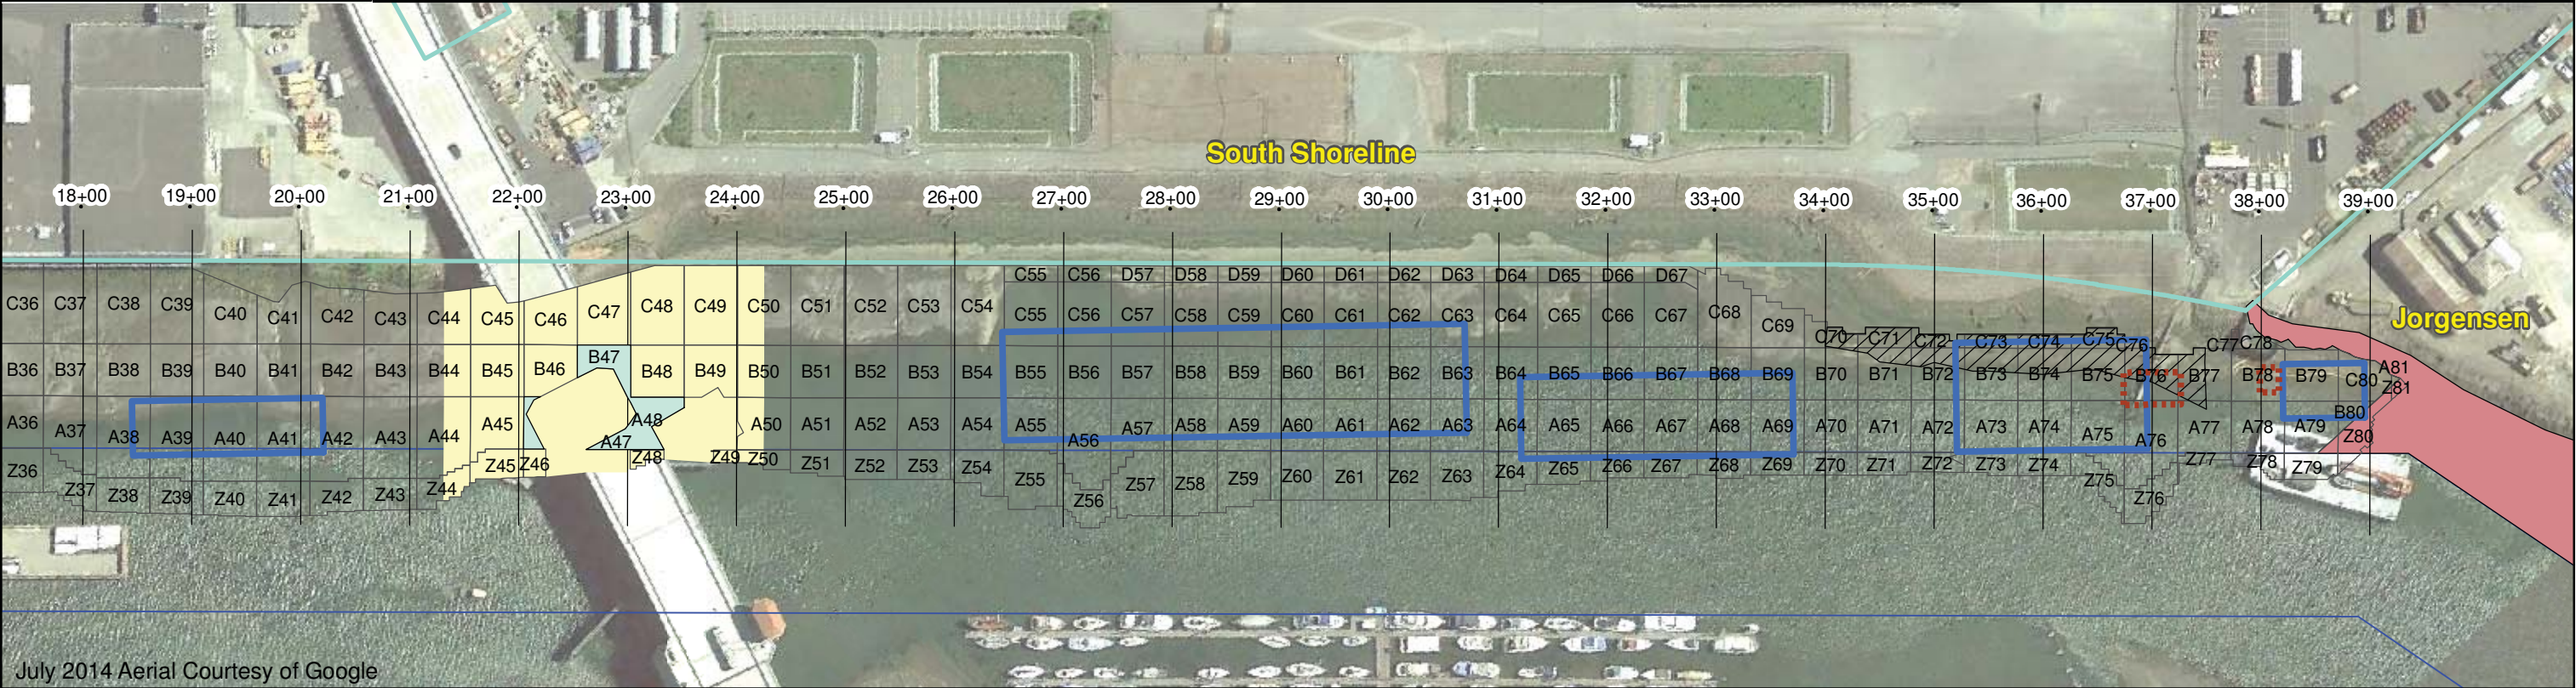
Construction Season 3 Work Areas

- Slip 4 Dredge Area
- SWB Re-excavation Area (approximate)
- Bridge Area
- Hydraulic Dredge Area

Due to limited access and the need to avoid damage or impacts to the newly constructed South Park Bridge, diver-assisted hydraulic dredging was performed in selected areas adjacent to the bridge (Figure 3) to remove impacted sediments to the design grade. Diver-assisted dredging is a commonly accepted practice in areas where access to sediment may be restricted by existing structures or where a low-impact dredging method is needed so that the dredge cannot damage structures within the dredge area. One tradeoff with diver-assisted dredging is that sediment production rates are very low compared to environmental mechanical dredging.

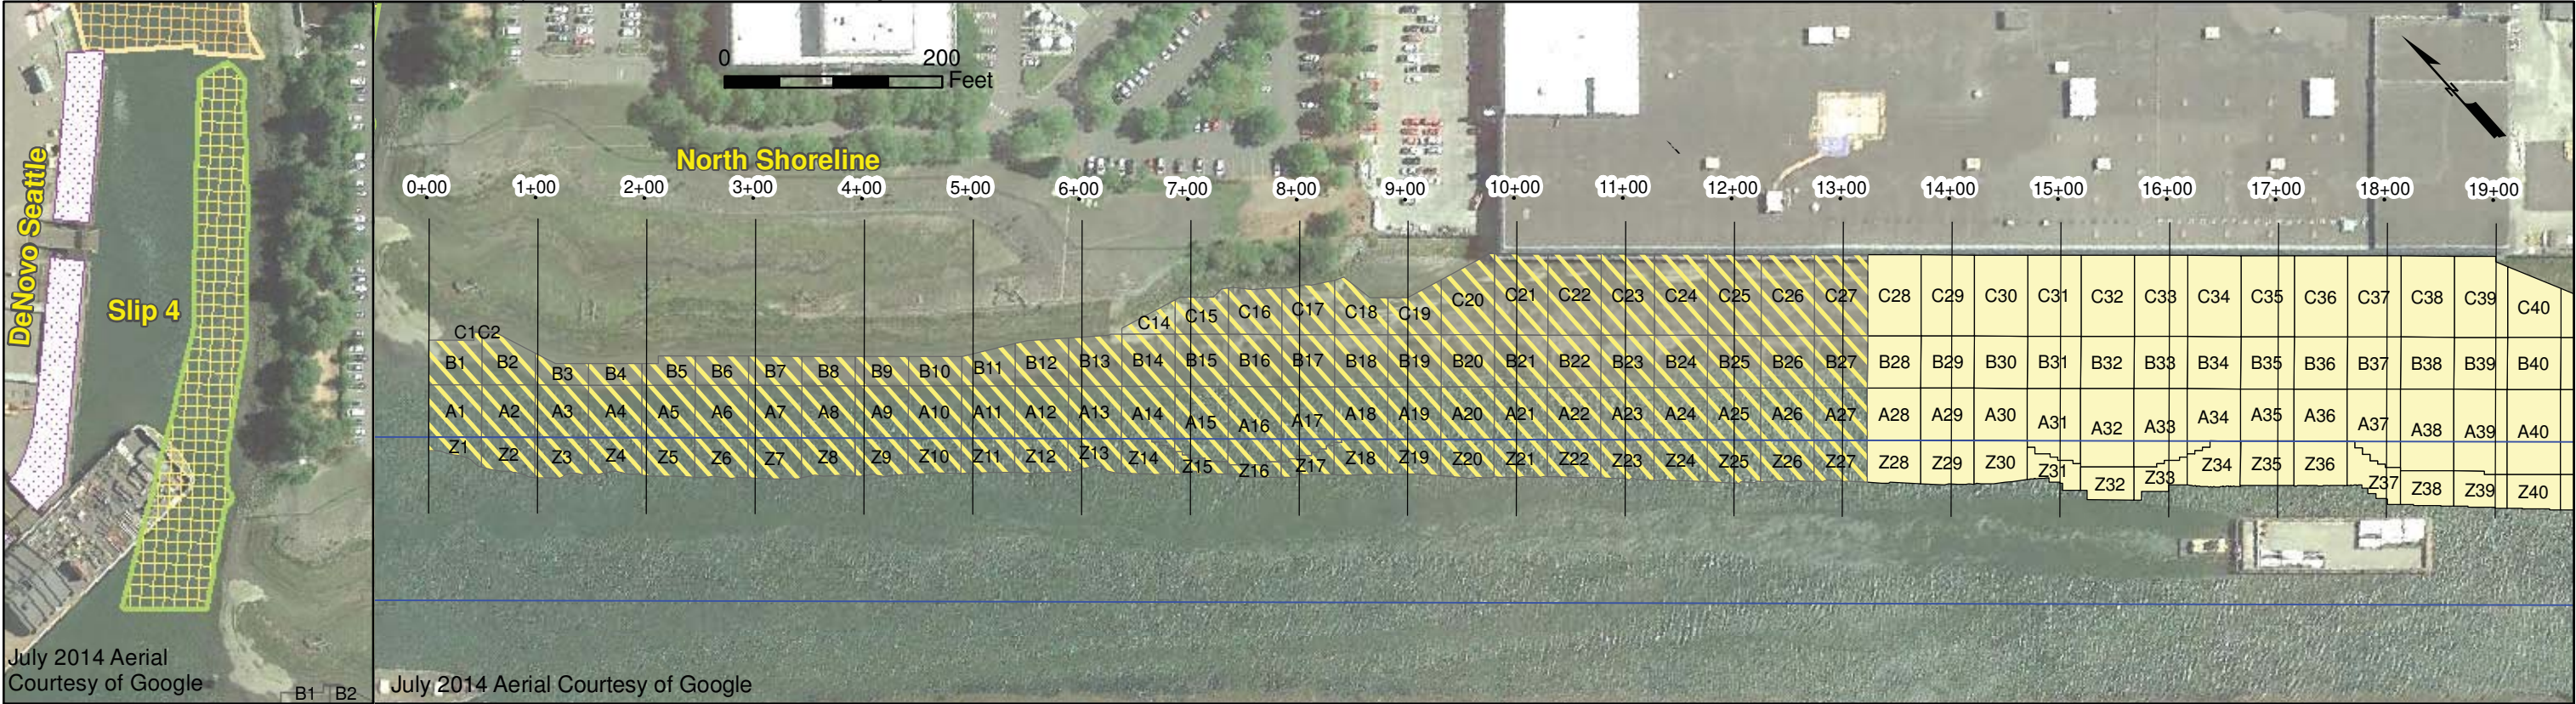
Construction Season 3 Work Areas

- Slip 4 Dredge and Final Backfill Area
- A39 DSOA Dredge and Final Backfill Area
- A6 DSOA Final Backfill Area

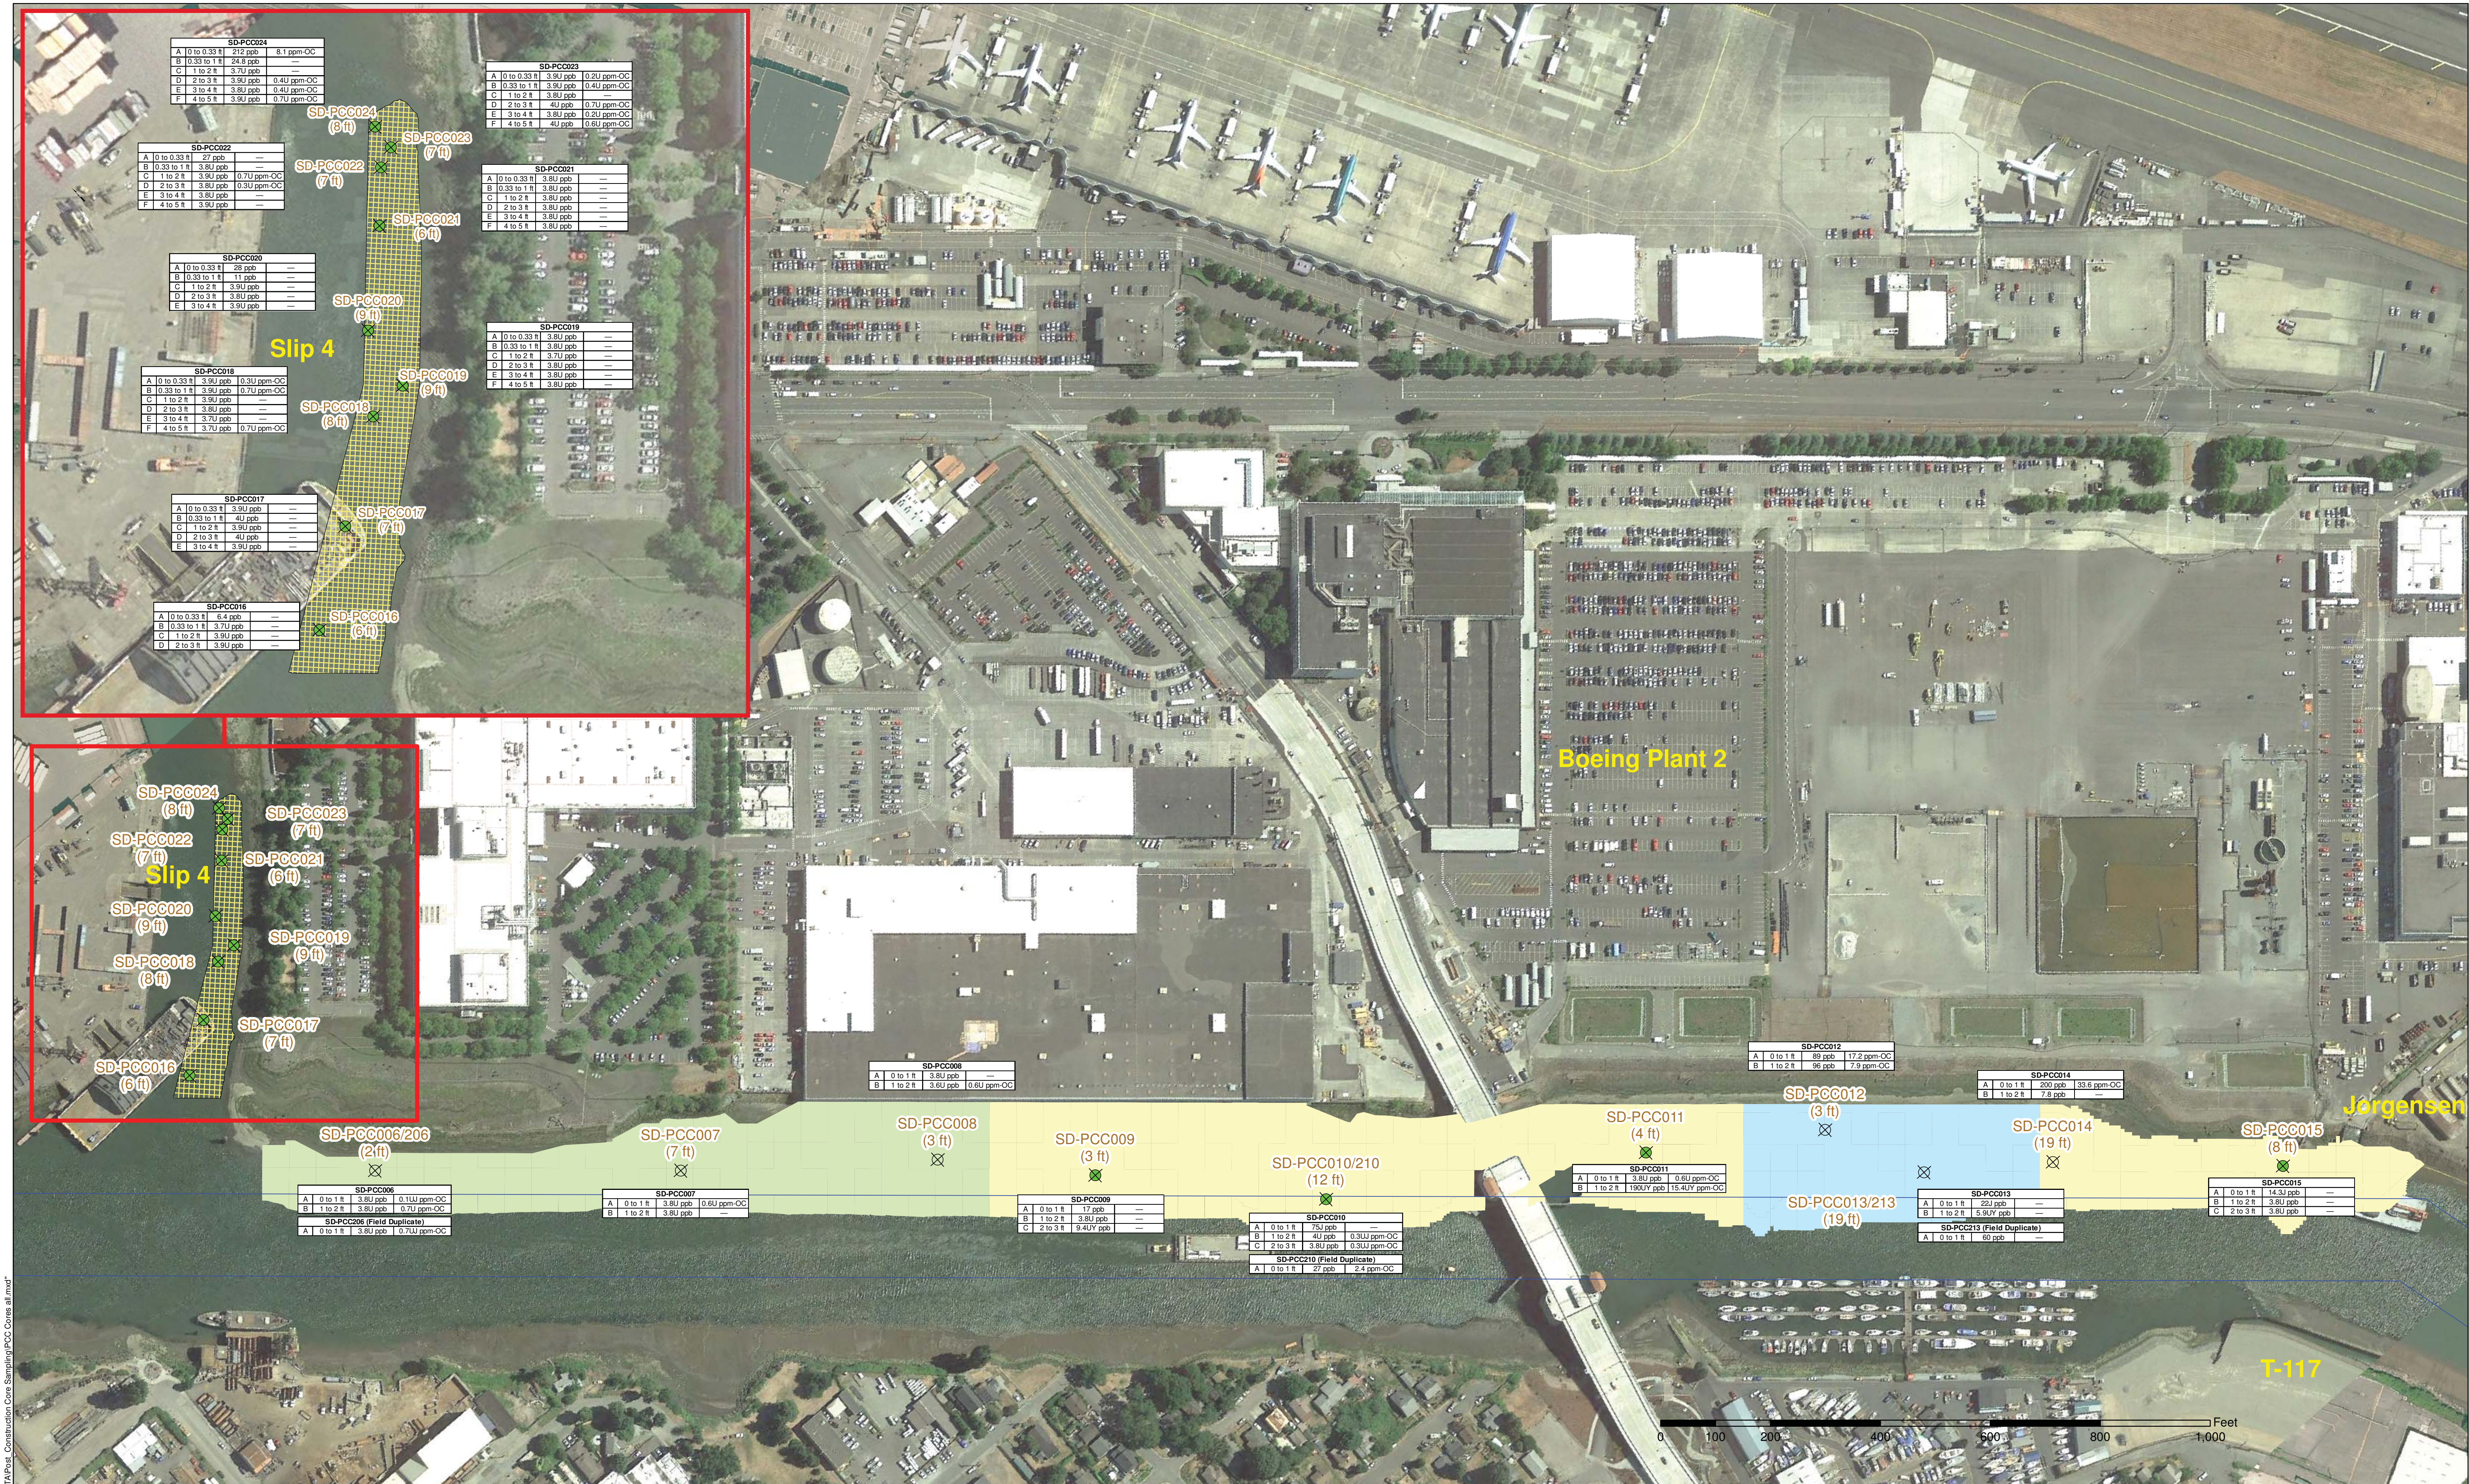
Figure 9

Post-construction Confirmation Cores
